Navajo Abandoned Uranium Mine Site Screen Report

Junior AUM Site

Navajo AUM Eastern Region

May 2009

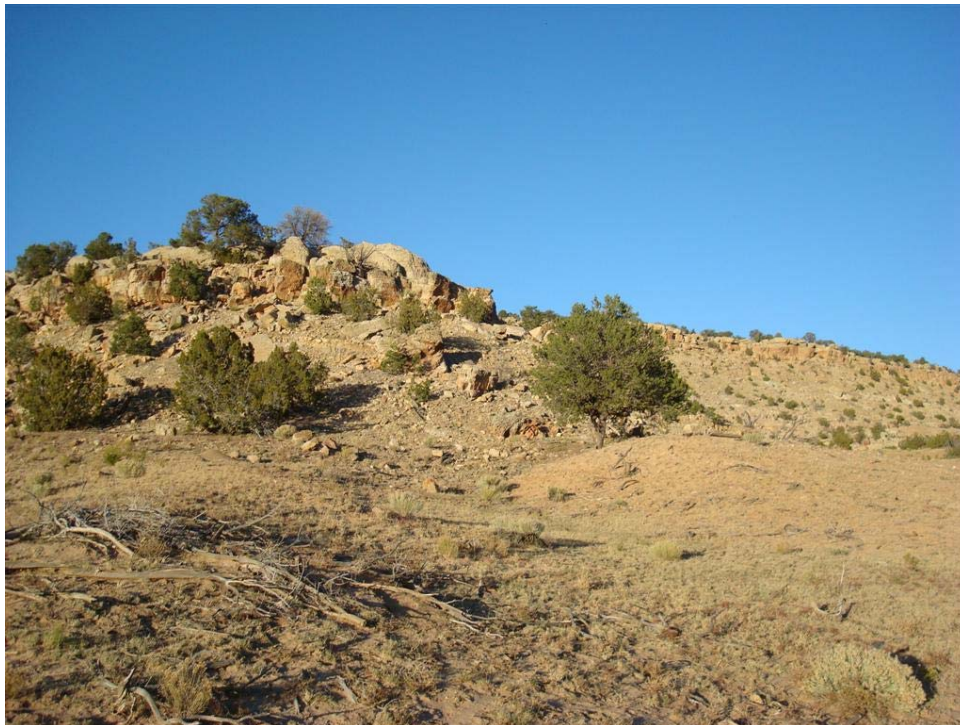
Reclamation status of the mine sites are currently unknown. No visible signs of reclamation were observed. Some indication of excavation occurring along the base of the bluffs. No waste piles, adits, or other mine features were observed during the site visit.

Photo 1. Junior Mine site, towards the north

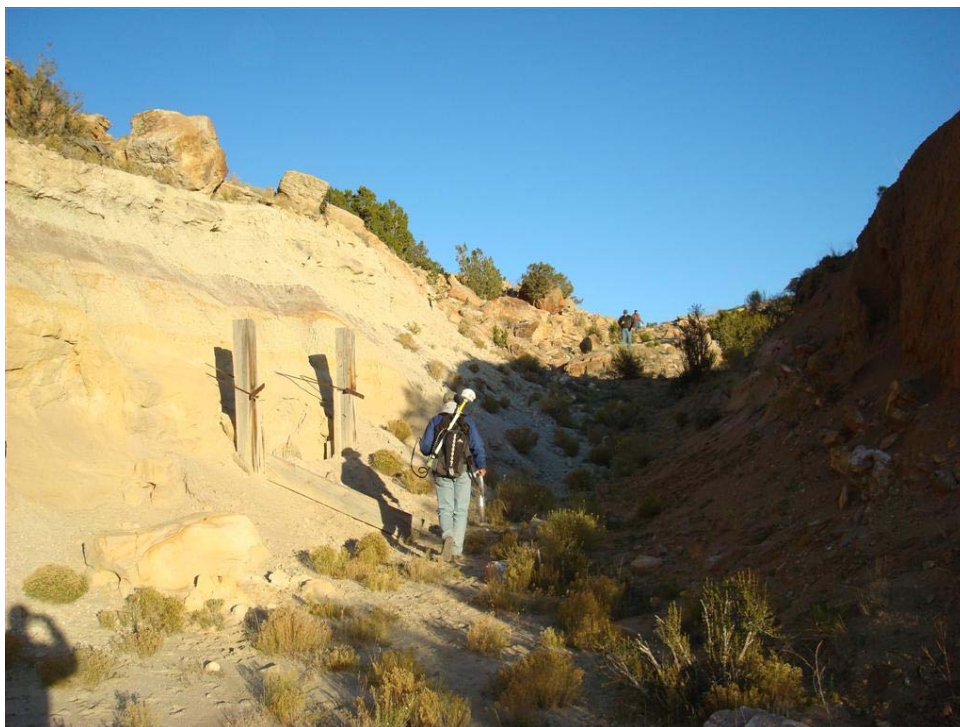
Photo 2. Junior Mine site, ravine towards the north
